**WATER SYSTEM EVALUATION**

**VERDE GLEN WATER COMPANY**  
GILA COUNTY, ARIZONA  
PWS ID # AZ04-04040

**February 2024**

Prepared for Arizona Department of Environmental Quality

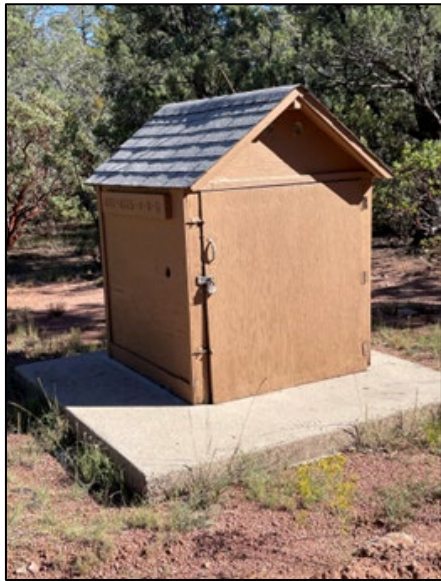
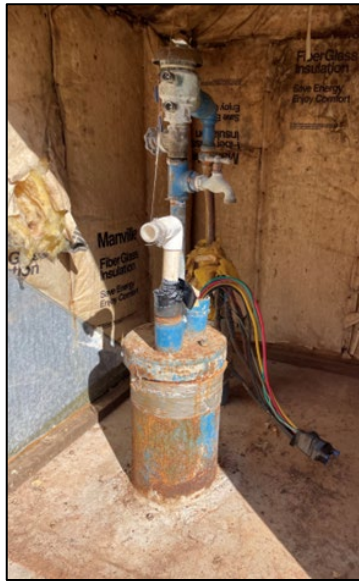
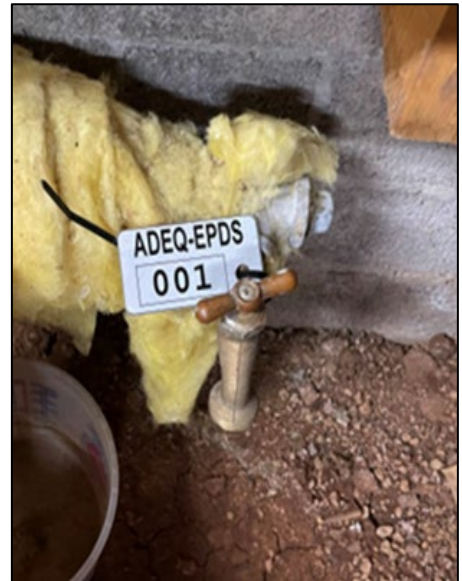
Well #1 (55-641886) - Active

Well #1 (55-641886) is the only active well in production. The water supply from this well is reported to be reliable, both in terms of capacity and quality. The well is not in floodplain.

The well pumps into the two 10,000 gallon storage tanks. In 2015, VGWC inspected the well, replaced seven sections of the well casing pipe, installed a new pump and flowmeter and upgraded the electrical system. The pump and motor were replaced again in 2022 due to equipment failure.

Well #1 works off the water level in the storage tank through telemetry.

- Install Arizona Department of Water Resources (ADWR) well number at Well #1.
- Cap Well #2 to prevent contamination of the aquifer.
- Assess the feasibility of installing a second well to provide redundancy and resilience.

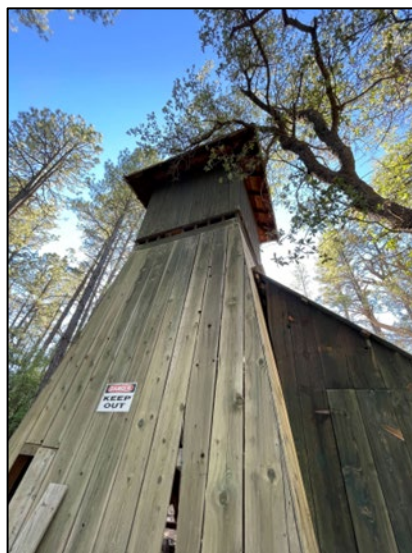
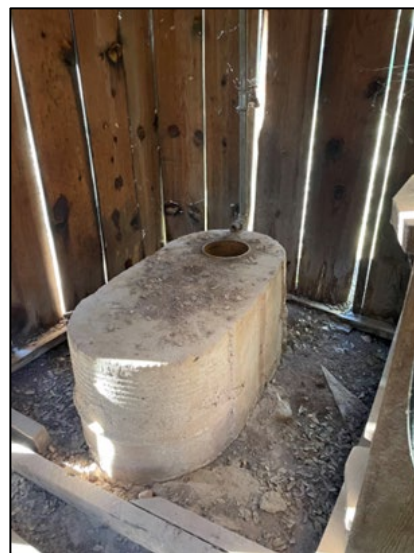
Well #2 (55-641887) - Abandoned

Well #2 (55-641887) has been abandoned because it was a poor producer and served only pressure zone VG3. Rehabilitating this well will likely be less beneficial than drilling a new well at the higher elevation (closer to Well#1).

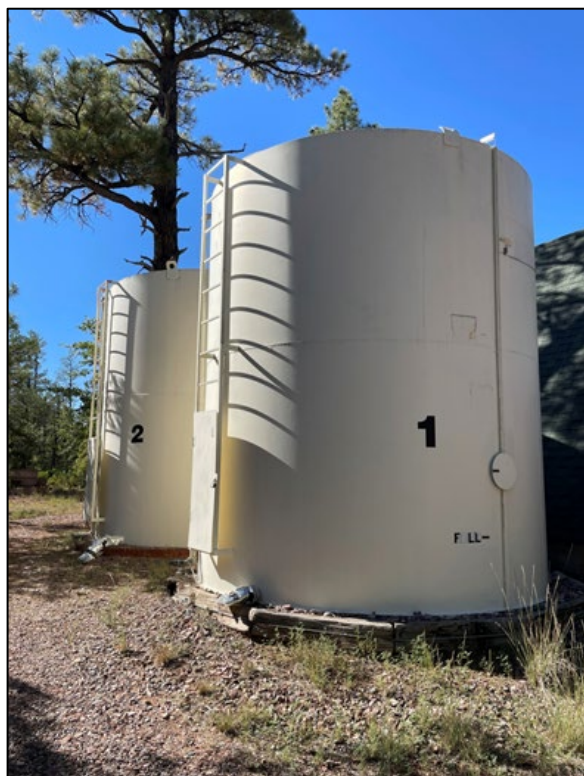
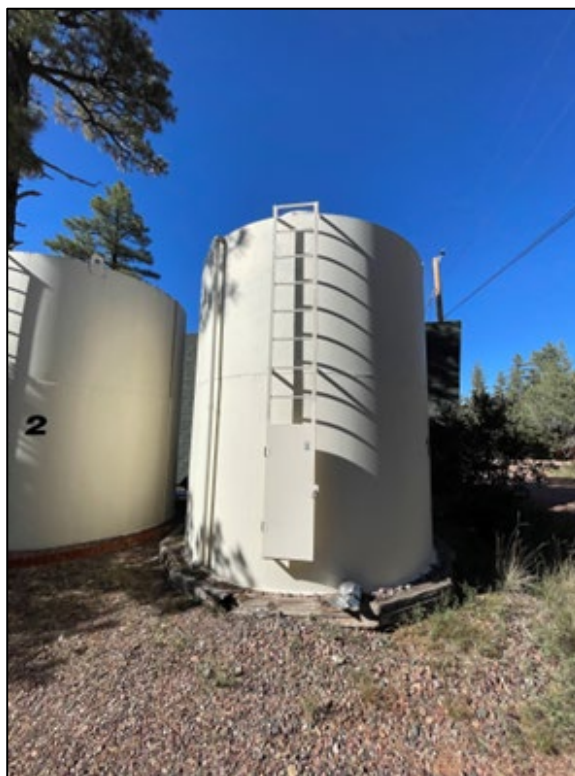
There are two 10,000-gallon, above-ground steel tanks. The tanks were constructed in 2002 and were refurbished in 2019. They are visually inspected through the roof hatches and are reported to be in good condition with minimal deposits in the bottom. The ladders are fitted with locked security covers. The tanks have operating water level indicators. The required storage capacity for the system is calculated as shown below:

There appears to be excess storage capacity in the two tanks, which can adversely impact water quality.

- Identify ways to prevent stagnation of water in the tanks. Alternatives may include modifying inlet-outlet piping, installing recirculation pumps inside the tanks, taking one tank off line during low demand months, etc.

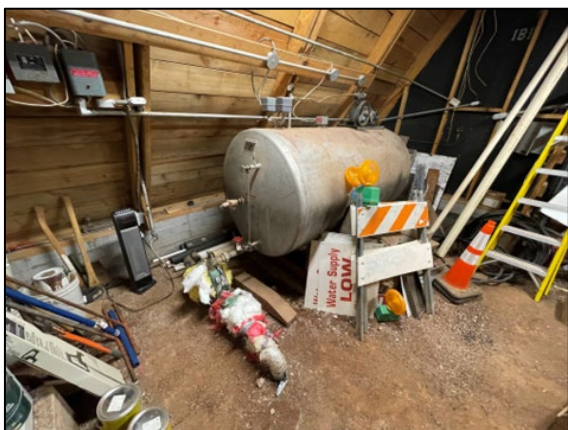
VG1 Pump & HP Tank

There is one 1.5 HP pump for each of the two pressure zones VG1 and VG2. Each pressure zone has a master meter to measure flow. The pumps work off of pressure switches.

- Prepare to replace VG1 pump, which is nearing the end of its useful life.
- Install a second 1.5 HP pump at each pump station to serve as backup.

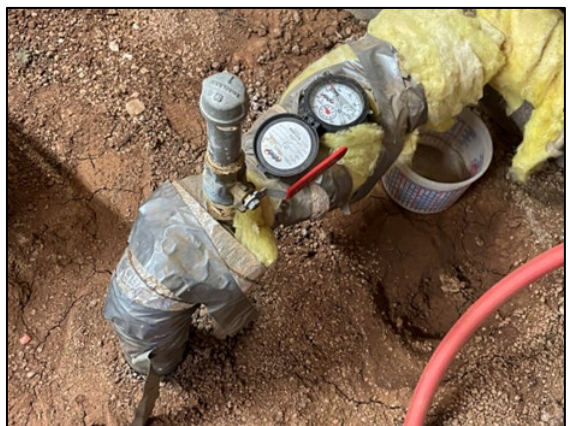
VG1 Mastermeter

There is a flow meter on the well discharge line and three master meters, one for each of the pressure zones. However, all the flow meters appear to be faulty and do not produce reliable data. According to VGWC, a total of 1,164,410 gallons of water was sold between Sept 2022 to August 2023 based on customer meter readings. The average demand, therefore, was approximately 3,200 gallon per day.

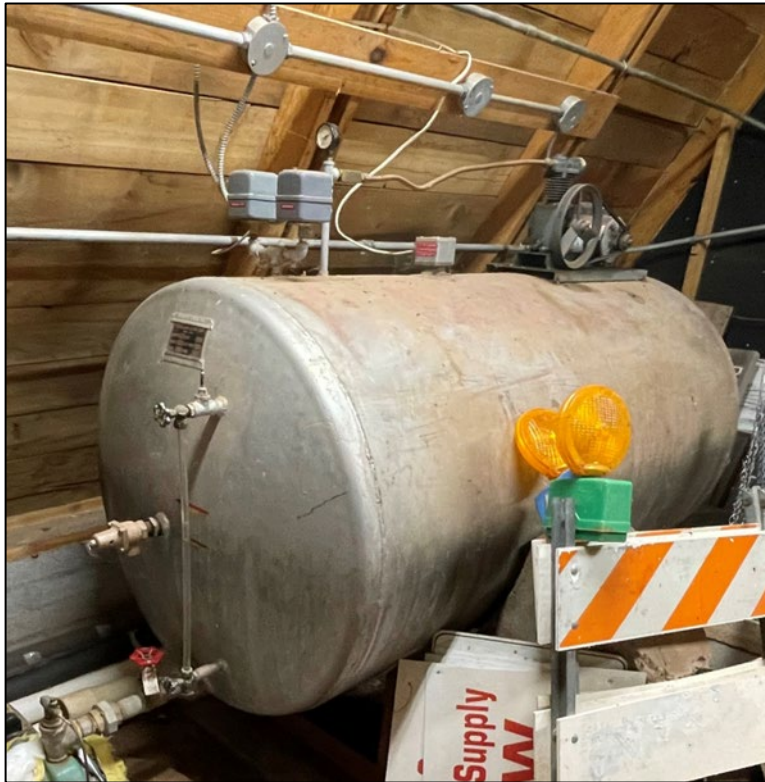
HP Tank at VG1 Pump House

The 500-gallon hydropneumatic (HP) tank was painted and refurbished in 2019. It is equipped with an air compressor and has a sight glass. There appears to be an adequate volume of air in it.

- Clean the space around the HP tank to allow quick access to the equipment in the event of an emergency.

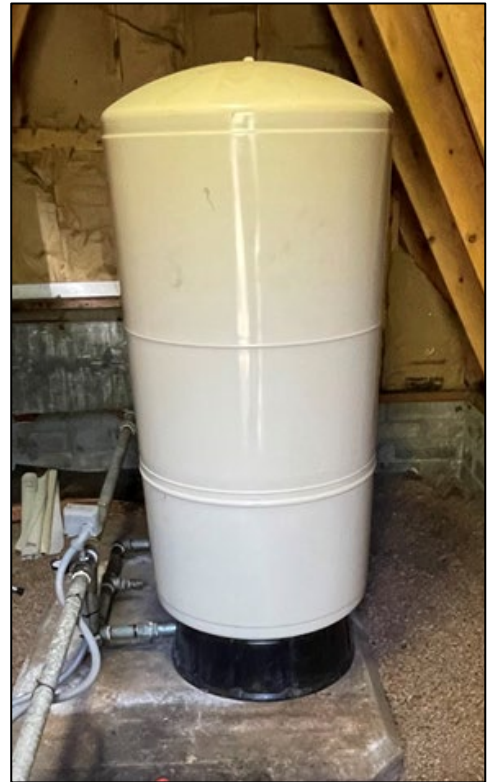
Bladder Tank at VG2 Pump House

The two 115-gallon bladder tanks were installed in 2019.

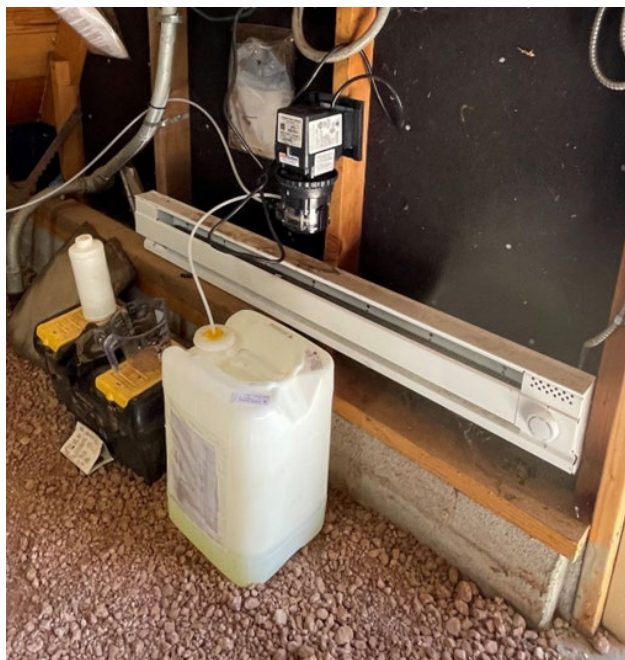
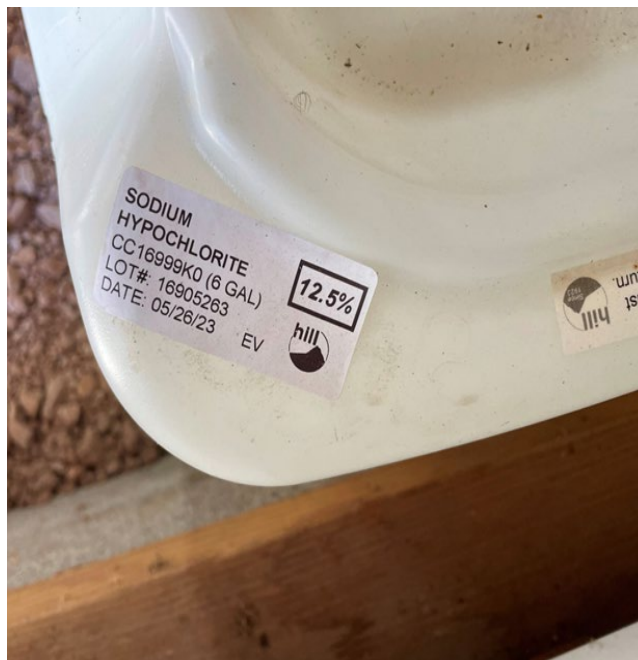
Chlorination System

The system chlorinates the well water going into the two 10,000-gallon storage tanks with 12.5 percent sodium hypochlorite. The chlorination system consists of a chemical tank, dosing pump and associated piping. The equipment is housed inside VG1 shed. Dosing is flow-paced based on the operation of the well. The facilities are currently inspected once/month and logs of the chlorine residuals are maintained.

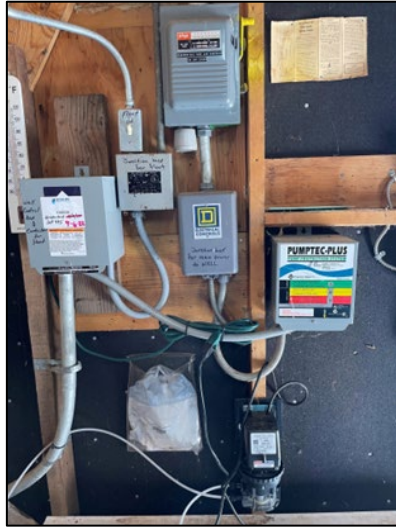
Electrical Controls at VG1

The system has controls in place to allow for automatic startup and shutdown of the well based on the tank level. Pressure switches control the operation of the booster pumps based on the distribution system pressure. There is an audible alarm for low tank level. There is no alarm for loss of booster pumps.

- Exercise the generator.
- Install a second generator at VG2 pump station.
- Install alarm for loss of well pump or booster pumps.

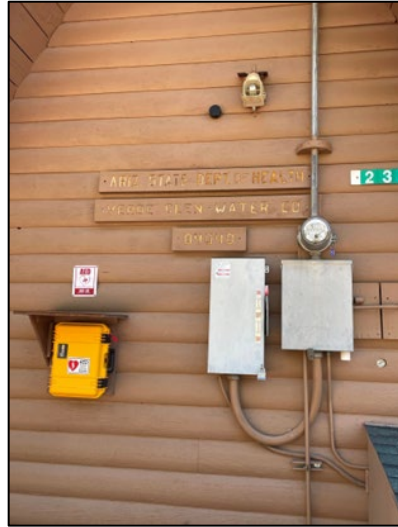
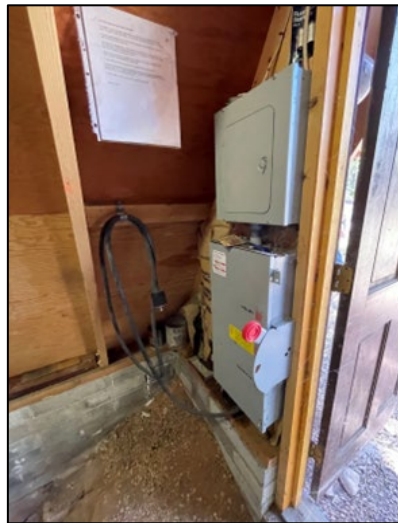
Electrical Controls at VG2

The electrical power supply is reported to be unreliable. The storage tanks have sufficient water to meet about five days of demand. There is a mobile generator that can power the well pump and the booster pumps, one equipment at a time. During power outage, zone VG1 or VG2 will be out of water due to lack of backup generator.

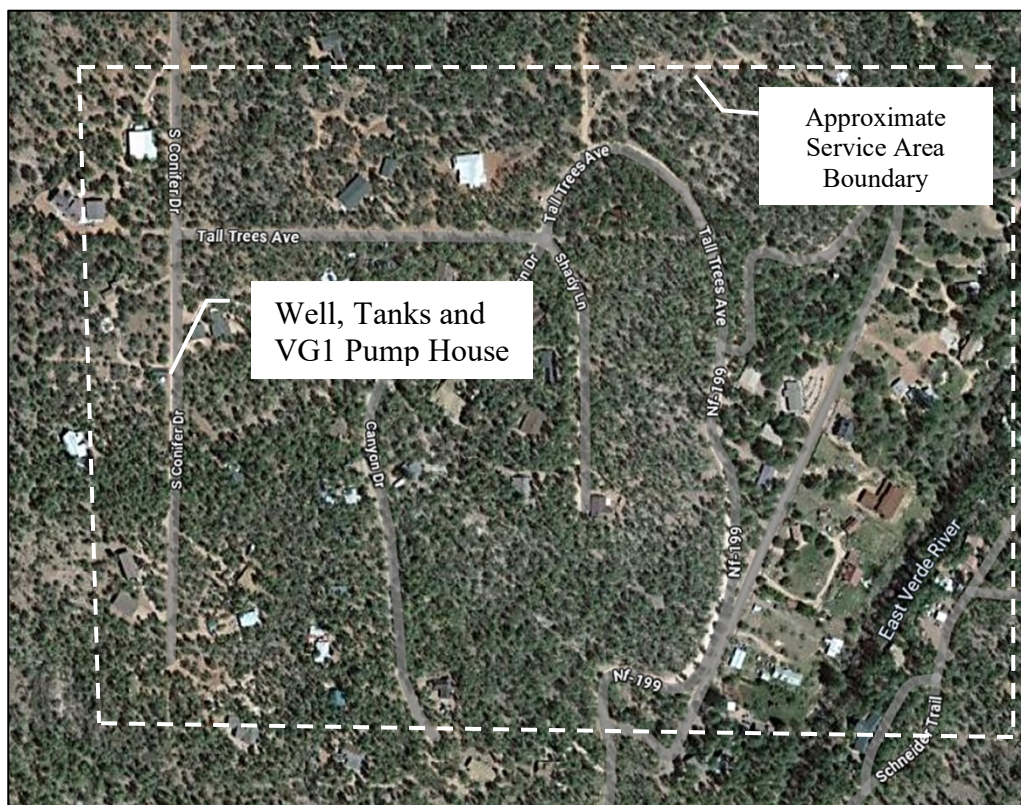
Layout of Service Area

The system service area is well defined. There are three pressure zones. The distribution pipes are old, improper material, poorly looped and have inadequate ground cover. Approximately 75 percent of the pipes were installed in the 1970s. Each pressure zone has one isolation valve, which is not routinely exercised. All customers are metered. Meters are read on a quarterly basis. Since the flow meters are not very reliable, it is difficult to estimate the water loss. The water loss is reported to be generally low.

- Replace the galvanized, ABS plastic and schedule 40 pipes with approved piping material.
- Provide better looping of the piping network and/or flushing valves on deadends.
- Digitize the distribution system map.
- Exercise the valves.
- Replace customer meters.
- Require customers with private wells to install back-flow prevention devices on their service lines to prevent cross-contamination.

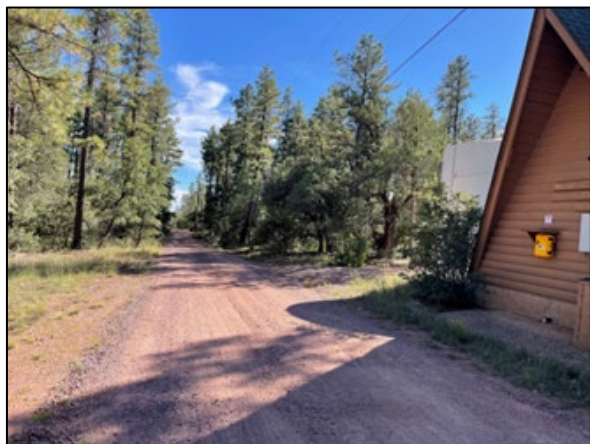
Streets are unpaved

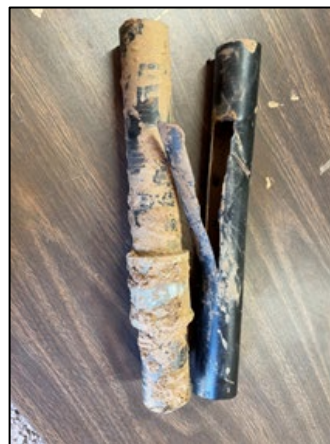
ABS plastic pipe likely broken under the weight of vehicle due to inadequate ground cover

| PRESSURE TANK | |
|---|---|
| 6. Are the mains at least 3-feet deep? <i>Some sections are only a foot deep and can be damaged by the weight of heavy vehicle</i> | NO |

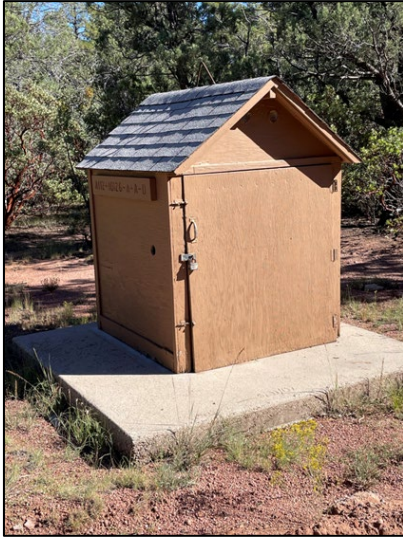
Well #1  
(In service)

Well #1 and the two booster pump stations are housed inside sturdy structures. Well #2 is inside an abandoned structure that is in poor condition. None of the facilities have identification signages. The facilities are in densely wooded areas that may be prone to wildfire.

- Clear trees and vegetation around the primary facilities to maintain a safe fire zone.
- Ensure the storage tank hatches are securely locked.
- Install signage at all three facilities showing the utility name, address, emergency contact information and the ADWR number of the well.
- Install “No Trespassing” sign on all sides of the structures.
- Tear down the abandoned Well#2 structure.
